Camera Calibration Verification
Model: DMC IIe 230 – 23526

For
Midwest Aerial Photography
7535 West Broad Street
Galloway, OH, 43119

Calibration Details

Calibration Overview

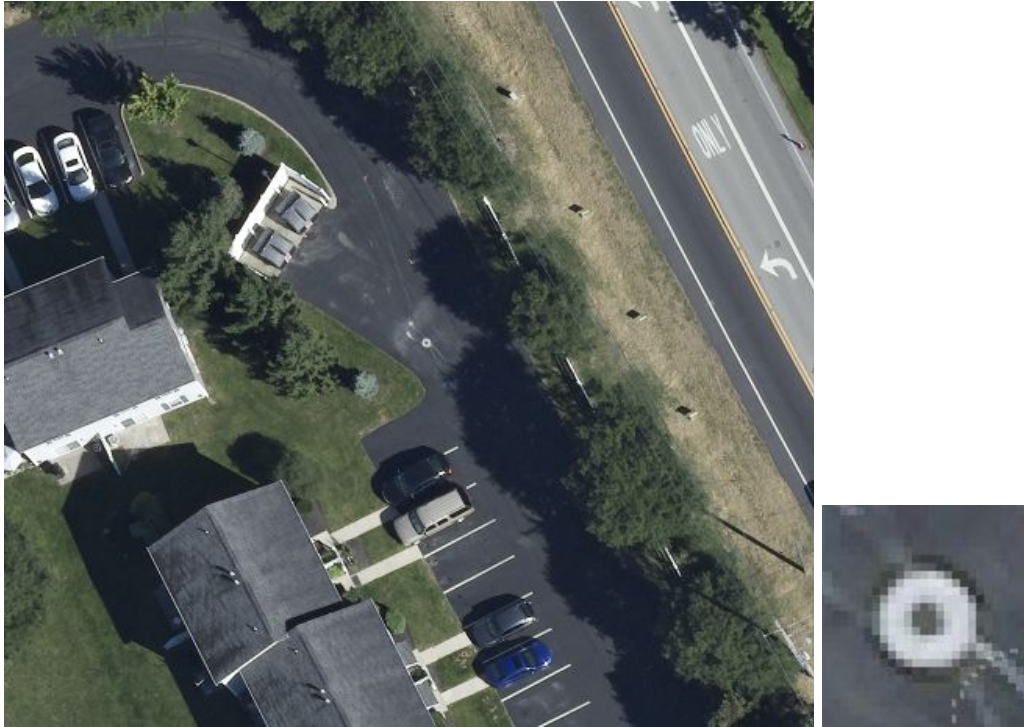
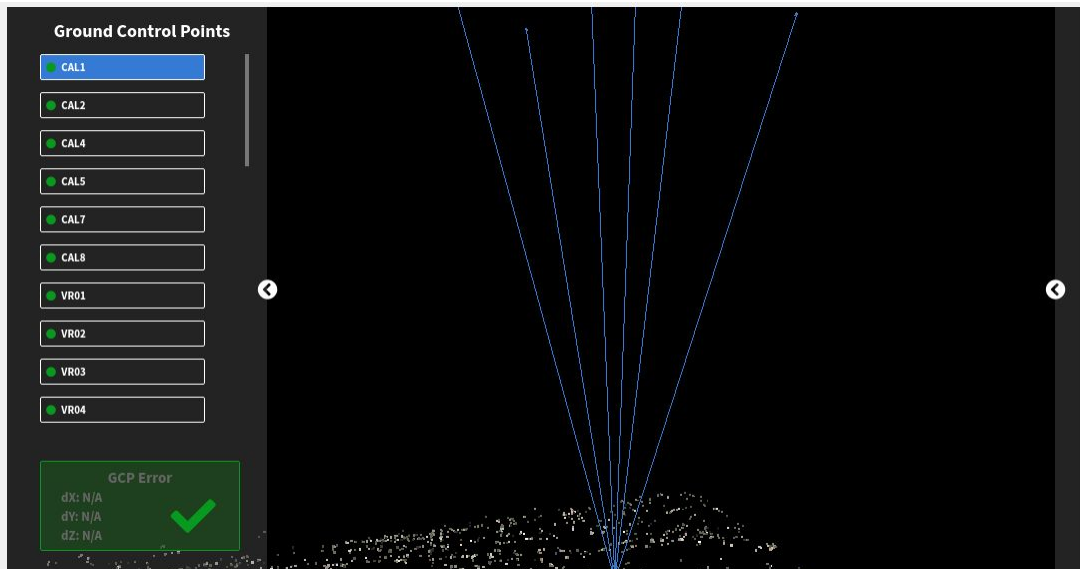
Figure 2: Ground control points were measured in observable images and multi-ray intersection was conducted to calculate the 3D position of the checkpoint. Ground control points were measured manually in the imagery.
